Conservation Project: Central Station Clock Tower

NSW Railway Conservation Guide

March 2013

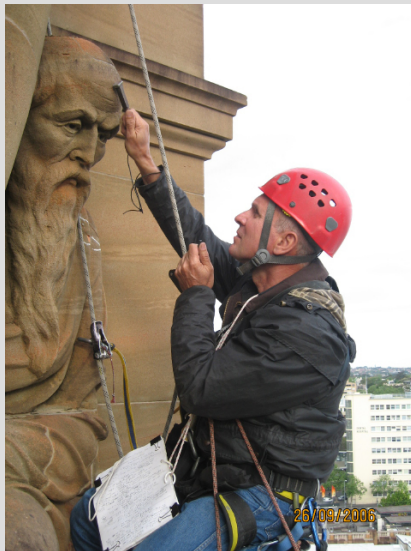
Stone-by-stone analysis during abseiling of Clock Tower (2006)

The elements of the tower which showed the most levels of deterioration when inspections were undertaken were the upper dome, top sections of the tower such as the large-scale decorative urns, projecting stonework such as cornices, string courses, balconies and the large statues around the tower clock-face. Each of the 3500 stone blocks on the outer face of the tower were labelled, inspected and documented. This included: stone number, stone location, stone finish, type of conservation action required, physical size of the repair, and photograph of defect.

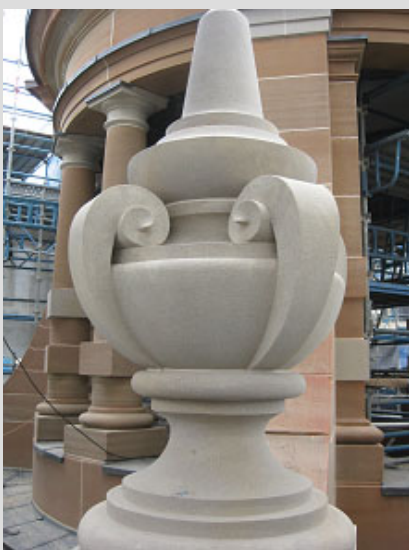
New stone urns stored on site (right) ready to be hauled via pulley up to the Clock Tower, and the new urns reconstructed (above).

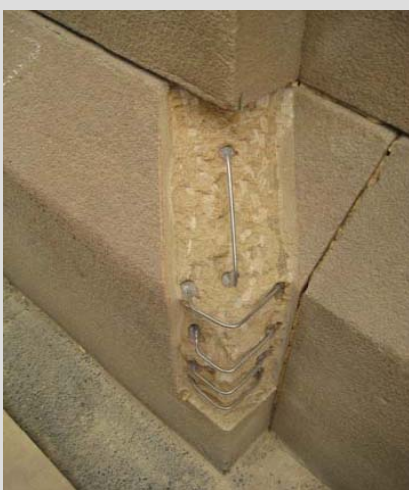
Stainless steel reinforcements typical of synthetic repair patches.

The use is also where safety issues are of a less of a concern. Hence, the repair of say a soffit of a cornice, using synthetic repair patches, would be extremely unsafe and is discouraged. Synthetic patches generally have a short lifespan of only 10 to 20 years. Extensive use of synthetic work will also result in need to re-scaffold a building about every 10 to 20 years. Hence their application is very limited in conservation work.

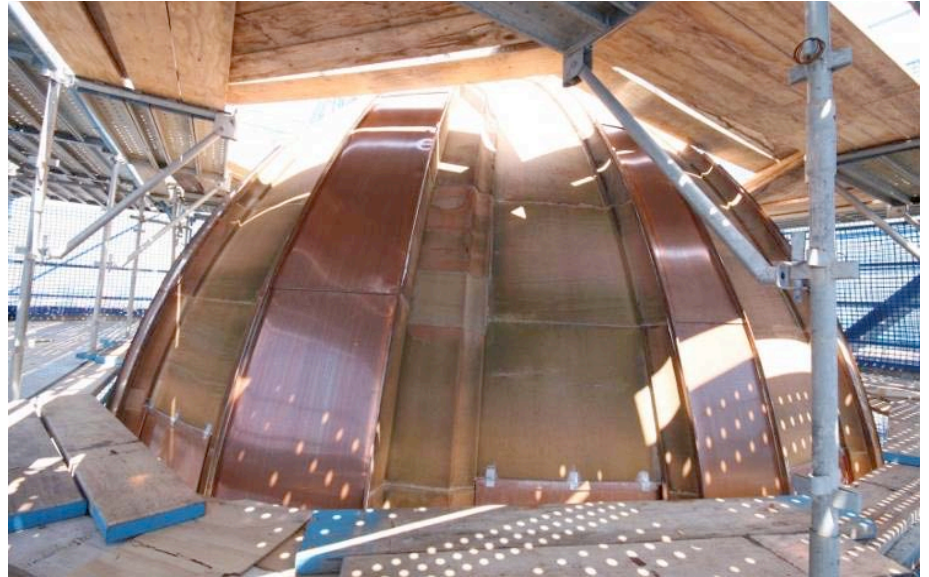
Reconstructing the dome in sandstone was considered as an option, however, due to ongoing weathering and exposure, the dome would have required further and constant repair in future years. As such, the option was put forward to clad the entire dome in copper, reflecting its traditional use in other domed grand public buildings in Sydney. The use of copper provides a suitable balance between practical conservation and retention of heritage fabric, by allowing the conservation of the original sandstone fabric in situ as well as assisting in the ongoing maintenance of the structure.

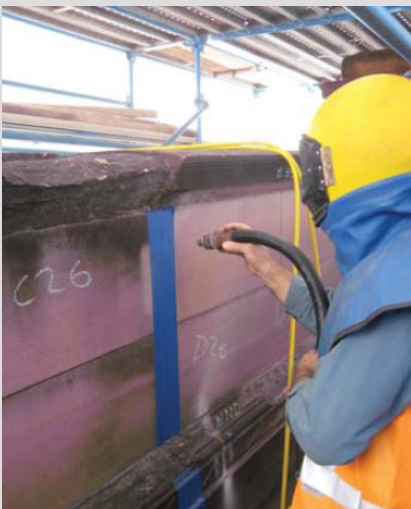
Many techniques are extremely aggressive such as sand or grit blasting. These should not be used on sandstone buildings. It is important that when cleaning processes are used an independent superintendent such as the architect monitors the pressures used and starts with a trial sample first. The best systems are where the pressure systems can be better controlled. At Central the specialised French 'Gommage' technique was used to gently clean stonework. This dry process does not require any detergent or chemical products and uses minimal abrasive elements.

Cleaning of sandstone.
